MANDATORY BULLETIN No.
SAFETY ALERT

EV97-028a SR
SPORTSTAR – 030a SR
SPORTSTAR MAX PTF-008a SR
Harmony LSA-008a SR

1. **CONCERNING:** All the aircraft of Eurostar, SportStar and Harmony types.
2. **REASON:** Insufficient insertion of the wing flap drive pins into the guides in flaps can cause wear of the guides and subsequent problems in operation. In the extreme case the loss of flaps controllability can occur.

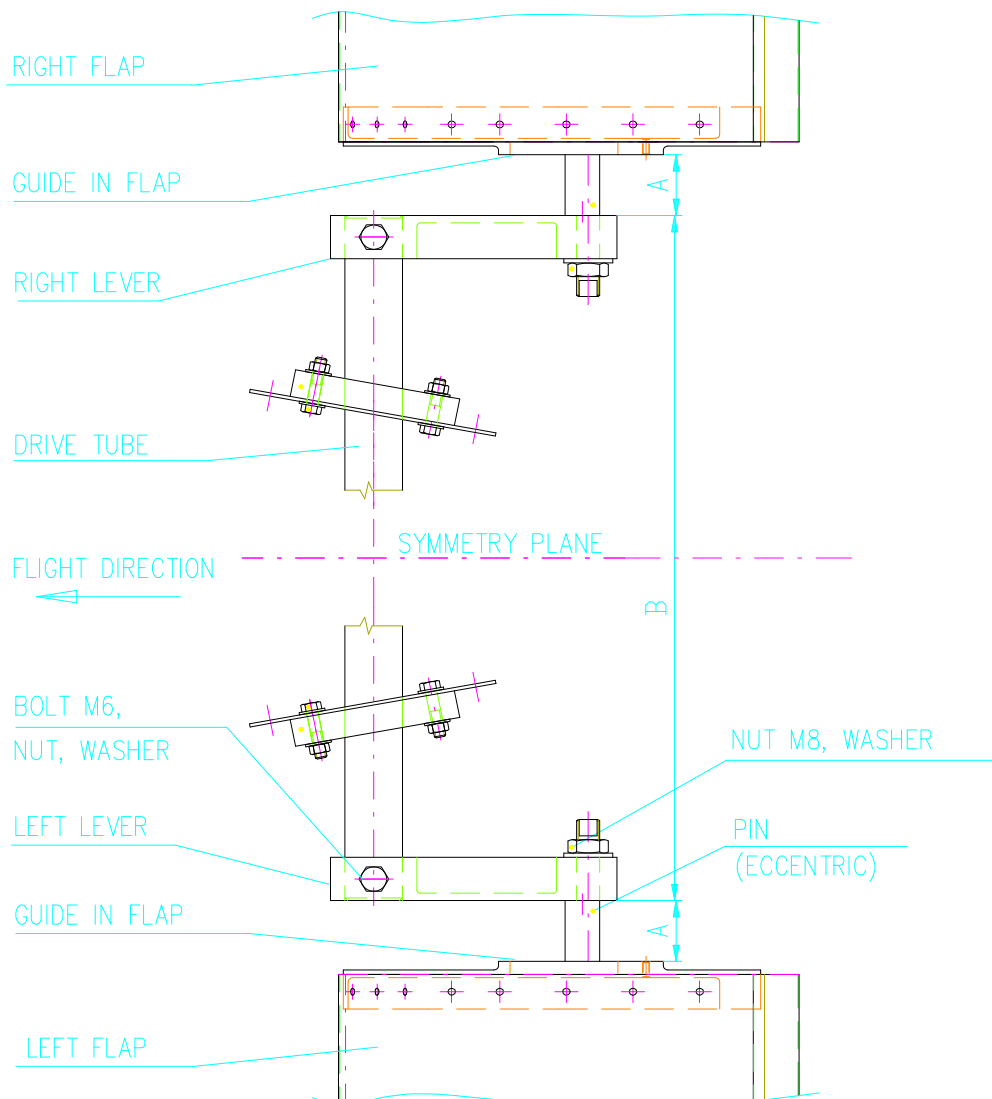
Fig.1

According to Fig. 1 check the play (clearance) between the drive lever with the pin and the nearest surface of the guide in the flap rib – **dimension A**. Check this play for each flap, always at full deflection of flap 50°.

Insertion of the pins is conforming if dimension A is smaller than 17 mm.

In this case just record the check performance according to the bulletin in the Aircraft Logbook.

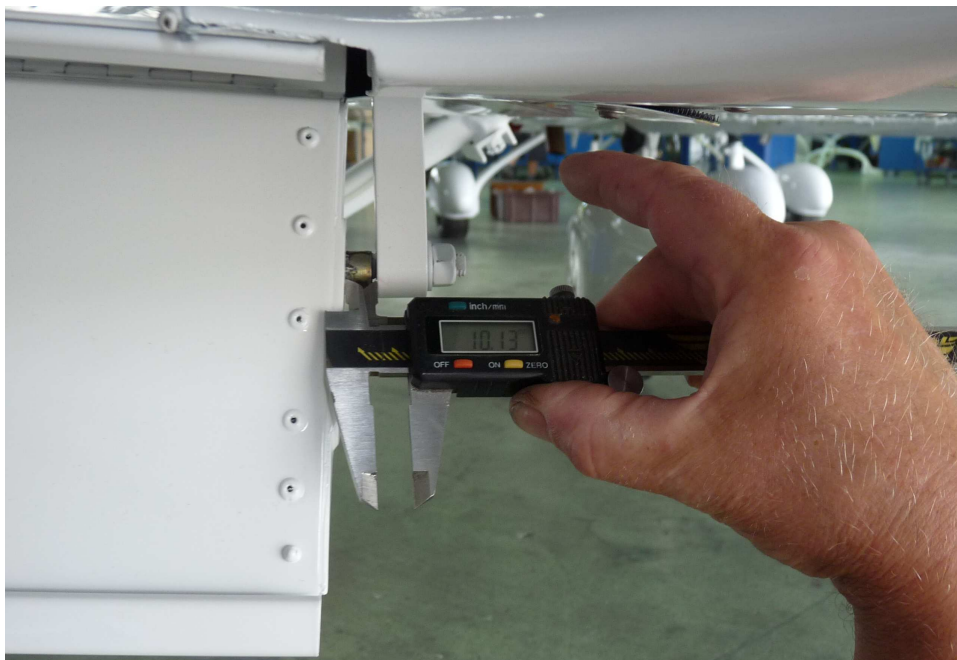
Fig. 2 – Measuring of dimension A at the left flap.

If the measured **dimension A is bigger than 17 and smaller than 20 mm**, continue according to point **1.2**; if the measured **dimension A is bigger than 20 mm**, continue according to point **1.3**.

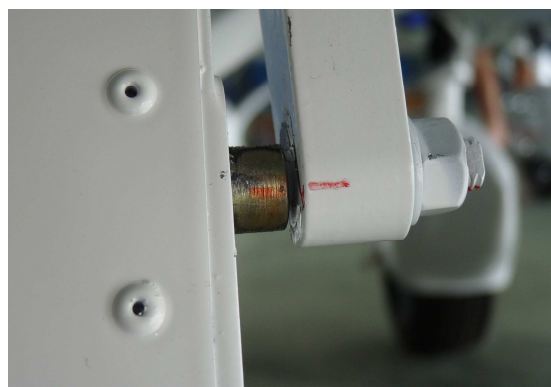
Fig. 3 – Marking of pin angular displacement position

1. According to Fig. 3 mark the position of pin angular displacement (the pin is eccentric). Carry out the marking with an indelible felt-tip pen by means of marks located against each other on the pin and on the lever.
2. Release the nut securing the pin.
3. Unscrew the pin by 1 up to 2 turns. Be careful that the marks on the pin and on the lever are located against each other. By this the play between the pin offset and the lever is increased – see Fig. 4. This play mustn't exceed the value of 3 mm.

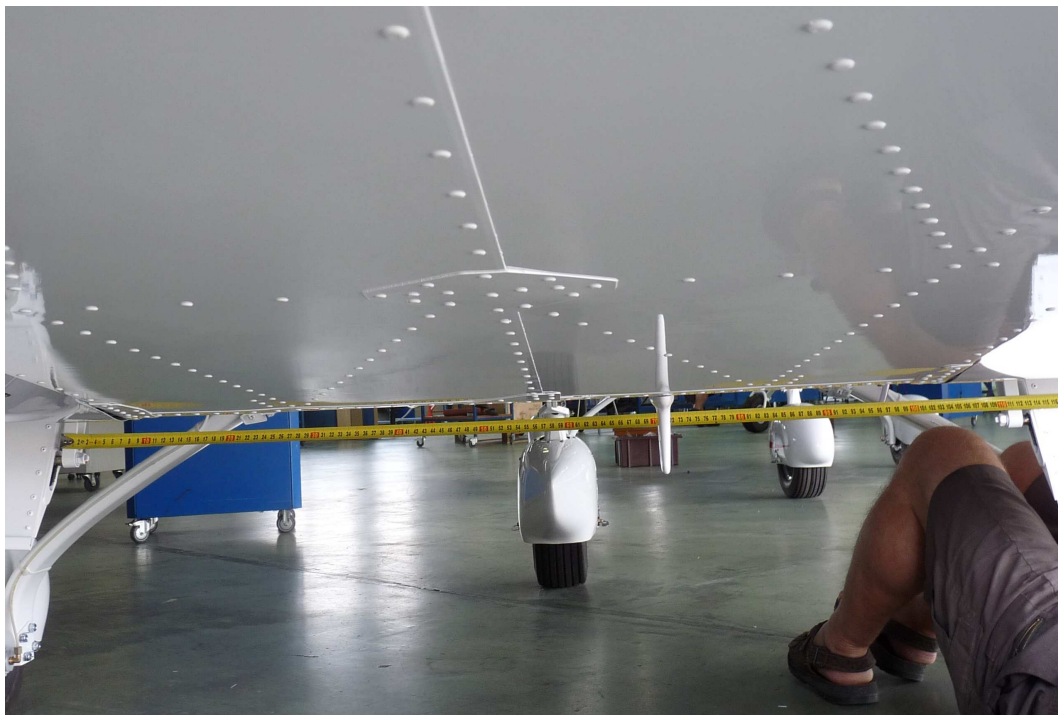
If measured dimension A is bigger than 20 mm, continue by measuring the distance between the outside edges of the left lever and the right lever with the pin – **dimension B** according to Fig. 5, 6, 7.

Fig. 5 – Measuring of dimension B

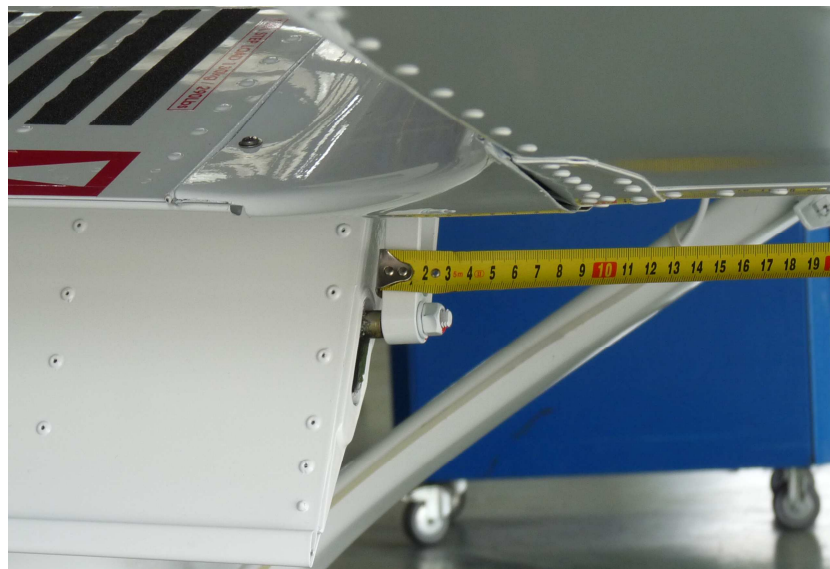
Fig. 6 – Measuring of dimension B

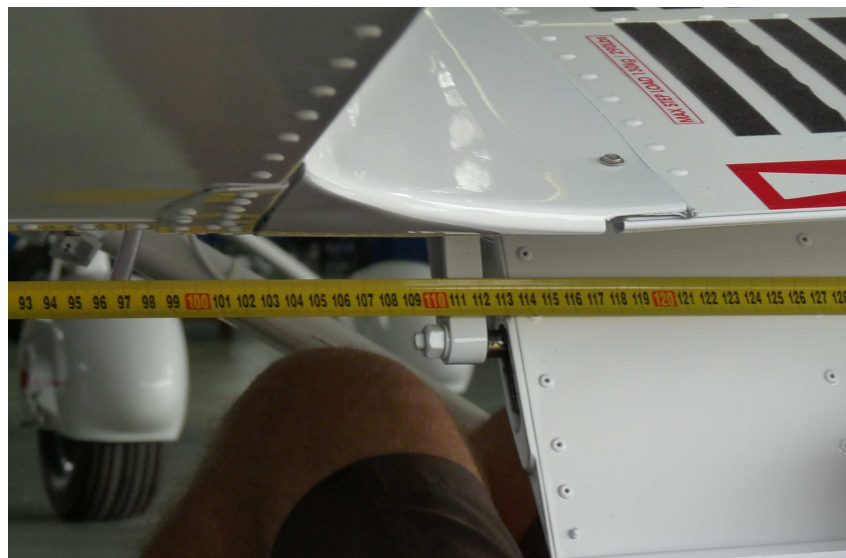
Fig. 7 – Measuring of dimension B

Immediately contact the manufacturer and inform him about the measured values of dimensions **A** and **B**. Provide the manufacturer also with the photo of the lever with the pin at the end and inform whether the lever has the stiffening rib on the edge or in the middle.
