SERVICE INFORMATION LETTER

DATE: October 3rd, 2018 **SIL-003/SZD/2018**

SUBJECT: Connections at elevator's drive in SZD-54-2 „Perkoz” sailplanes.

MODELS AFFECTED: All S/N of SZD-54-2 „Perkoz” up to S/N 542.A.18.021W (included).

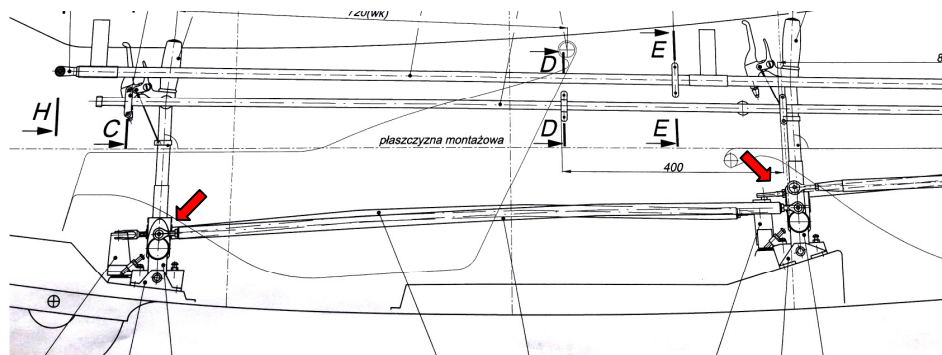
Pic. 1 Control's drives inside the cabin

It has been reported by the user, as one of the sailplane under intensive exploitation, got into disconnection of elevator's drive, at front seat, in flight. The a/c landed safely. After removing of front control's stick cover, the complete disconnection of the pushrod from the flying controls had been found. The incident is under investigation of appropriate AAIB.

- type and conditions of applied nuts (the type of nuts approved to use are: **H-M6** acc. to BN 73/1117-01 or **M6** acc. to DIN 980V, ISO 7042, NF E25410 or BS 4929-1). The nuts should not be used twice, in case of prior-disconnection of drive;
- the number of protruding threads should be min. 1,5 threads or – in case of thread depth is measured – not less than 1,5 mm.

1. Check visually of all the connections on the elevator's drive inside the cabin:
 - remove the front control's stick cover;
 - remove the seat pan from the rear seat;
 - check the connections of both flying controls with appropriate push-rods, as show on Pic. 1 (red arrows):

In case of found discrepancies to the above conditions, correct as necessary.

After screwing the connections, the marking by paint is recommended.
