SERVICE BULLETIN - SB031

Doc. No.:	SB031
Revision:	00
Rev. Date:	13/12/2023

I.C.P. Srl

SERVICE BULLETIN 31 - Extruded of Main Spar-Rev00

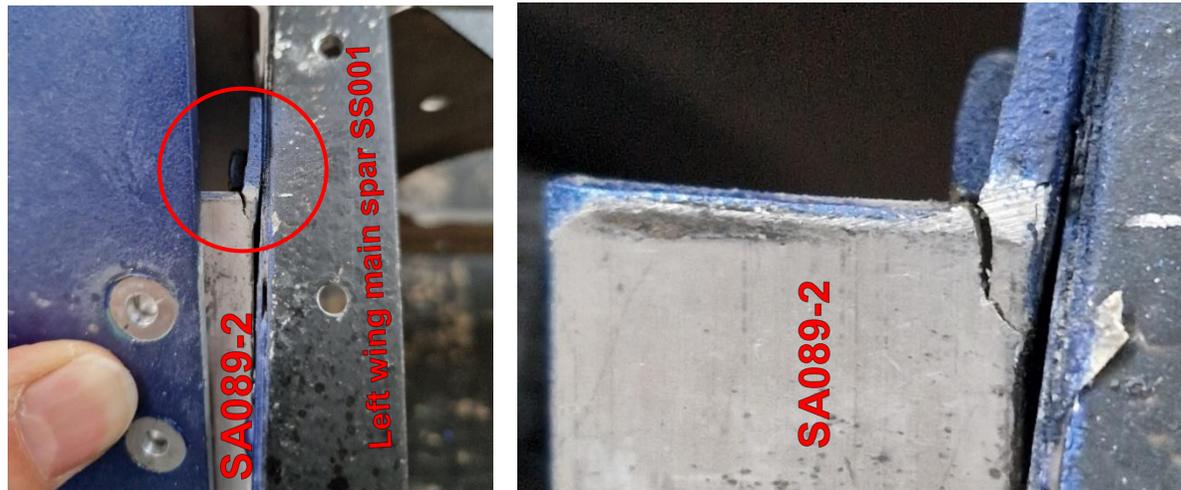
Figure 1: Left front strut attachment to the spar

Replacement of the extruded bars of the main wing spar attachments: SA089-2 and SA090-2. See *Figure 1* and *Figure 2*.

On the *Savannah VG* aircraft, it has been discovered a crack on the subject parts, during a reparation of the wing.
